# Eliminating FCC Regenerator Afterburn

*Ray Fletcher*

# Goal of the Study

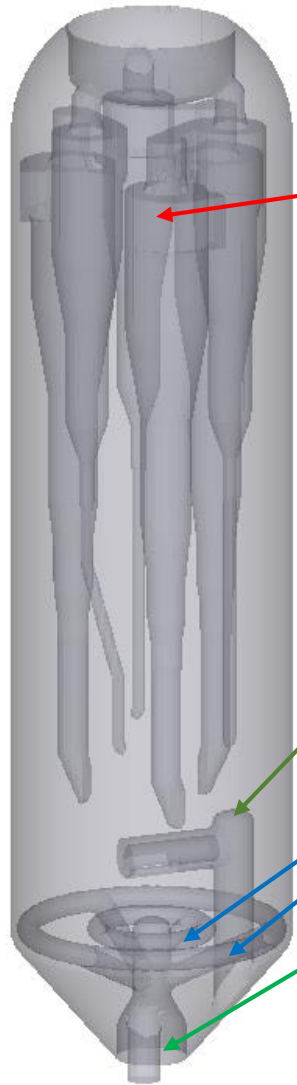
# Regenerator Internal Structures

**Overview:** The FCC regenerator is 70' tall with an internal diameter of 18' 10". The 3D cad displays the primary internal hardware:

- **Cyclones** – Three primary and three secondary cyclones are included in the model.
- **Spent catalyst distributor** – Spent catalyst enters the regenerator through the distributor. A substantial fraction of total air enters through the distributor.
- **Air rings** – Fluidizing air enters through 415 nozzles located on two air rings.
- **Regenerated catalyst standpipe** – Regenerated catalyst leaves the system through the Regenerated catalyst standpipe (RCSP)

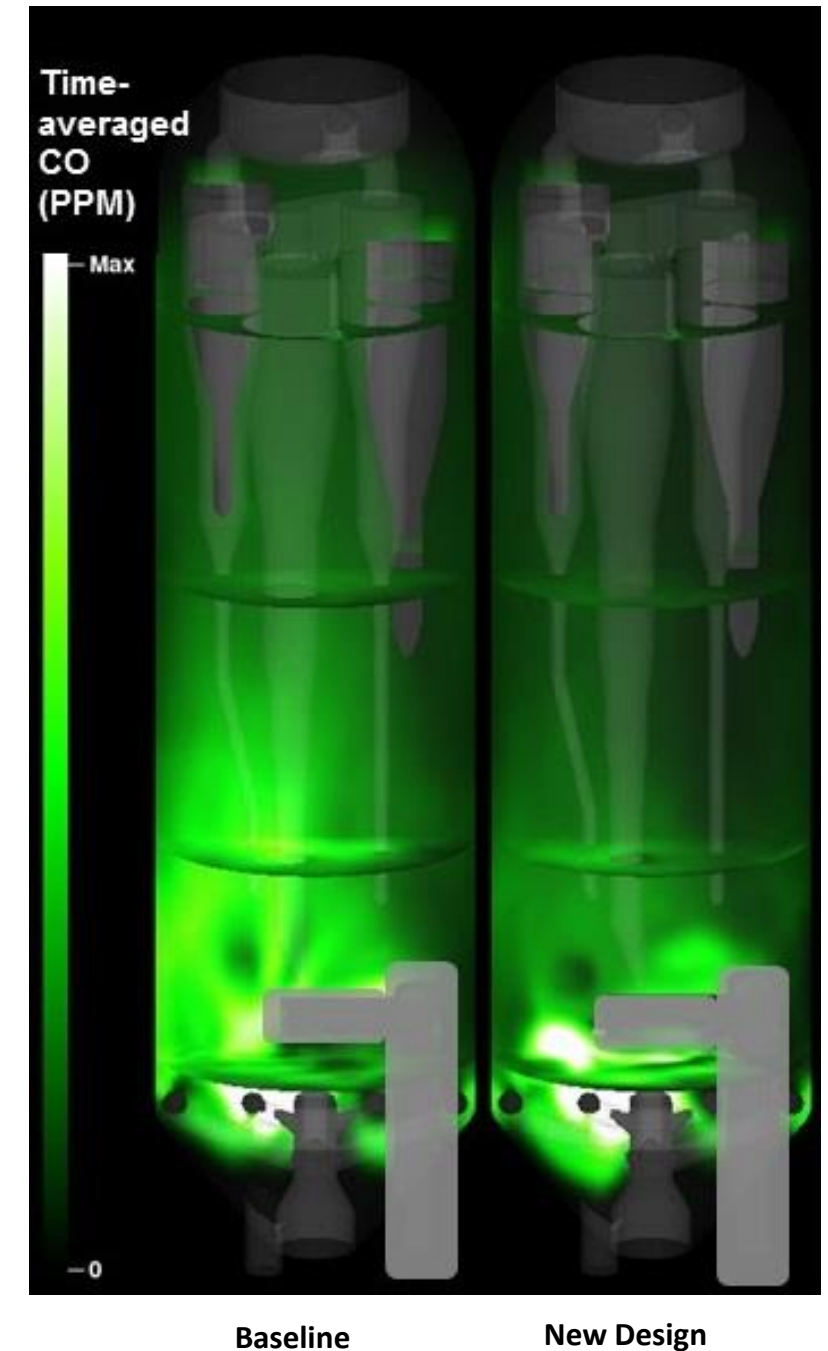
# Improved Regenerator Design (2)

- The improved distributor significantly reduces CO levels and afterburn
- Close collaboration between the refiner, the engineering company & CPF D enabled the refiner to verify whether the proposed distributor would actually eliminate afterburn

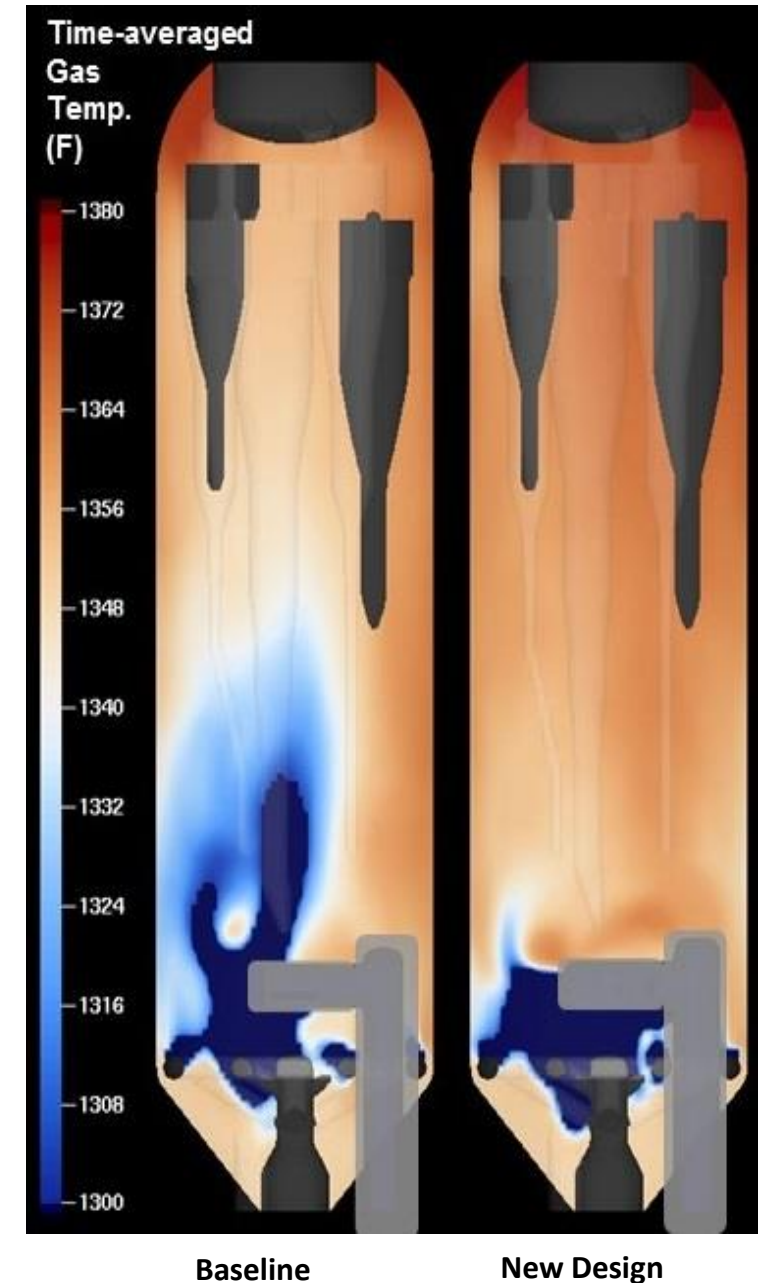
Proprietary distributor design details omitted

- An improved spent catalyst distributor design was recommended based on the simulation results
- The alternative distributor was designed to:
  - More uniformly distribute spent catalyst within the bed
  - More uniformly distribute the combustion air within the bed
- A comparison of the simulation results for the improved spent catalyst distributor shows a much more uniform temperature profile in the bed

- **Significant maldistribution exists due to poor spent catalyst distributor design**
  - Majority of the spent catalyst by-passes the regenerator bed resulting in combustion in the dilute phase
  - Excess oxygen is present in the center of the regenerator while excess CO is present along the walls resulting in significant afterburn
- **A collaborative approach led to a significantly improved distributor design**
  - CPFD, refiner & engineering company
- **CPFD strongly recommends similar collaborations to ensure successful revamps in FCC & other processes**
